Case Story

BenchTop extraction at manicure salon in Sweden

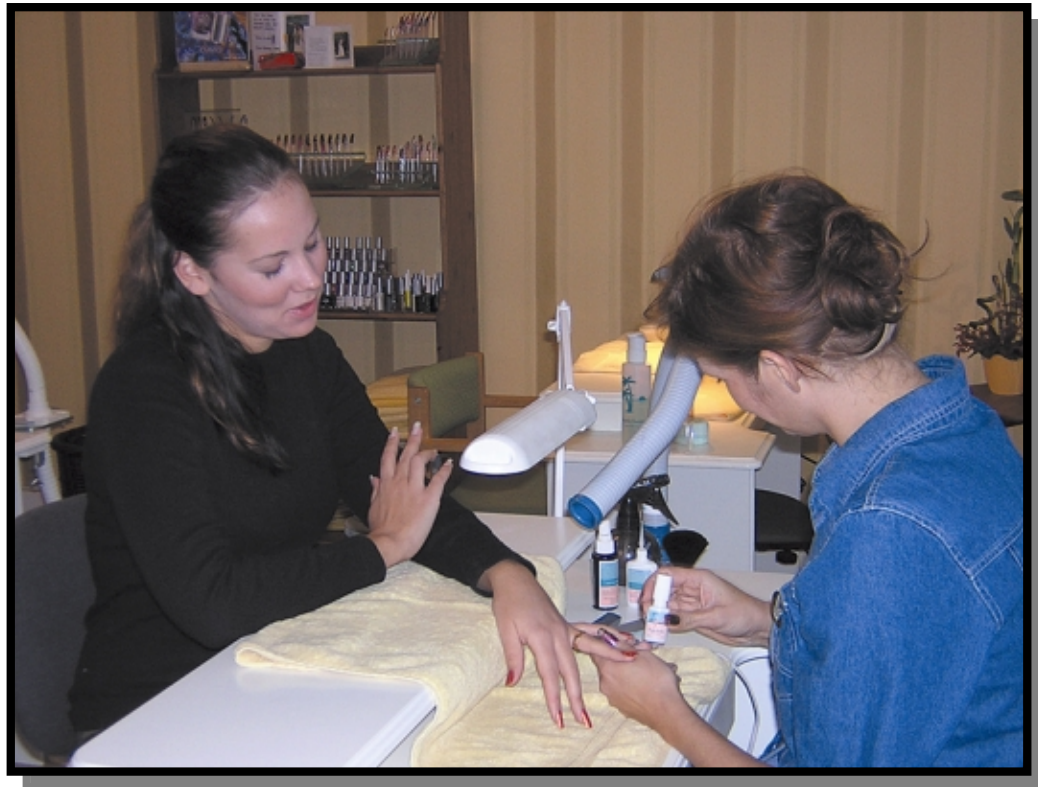
Solution: A Nederman EK500 BenchTop kit, (i.e. FX32 arm and CX5500 filter) was installed on the workbenches. This solution very efficiently captures the vapours directly at the work spot.

- Benefits:**
- The problem with noses stopped up, irritated eyes and asthma has already been dramatically reduced.
 - The noise level of EK500 is very low, a major advantage that this type of work is done in a quiet and relaxed spa-environment.
 - The kit is very easy and flexible to install as it is complete with arm, hose, filter/fan and table bracket.
